**Washington State Ferries  
Report of Formal Investigation  
M/V Cathlamet Allision with Fauntleroy Dolphin and Subsequent Grounding  
17 February 2023**

Investigating Authority: Washington State Ferries

Investigation and Report Preparation: Bill Michael, Operations Manager WSF Eagle Harbor Facility

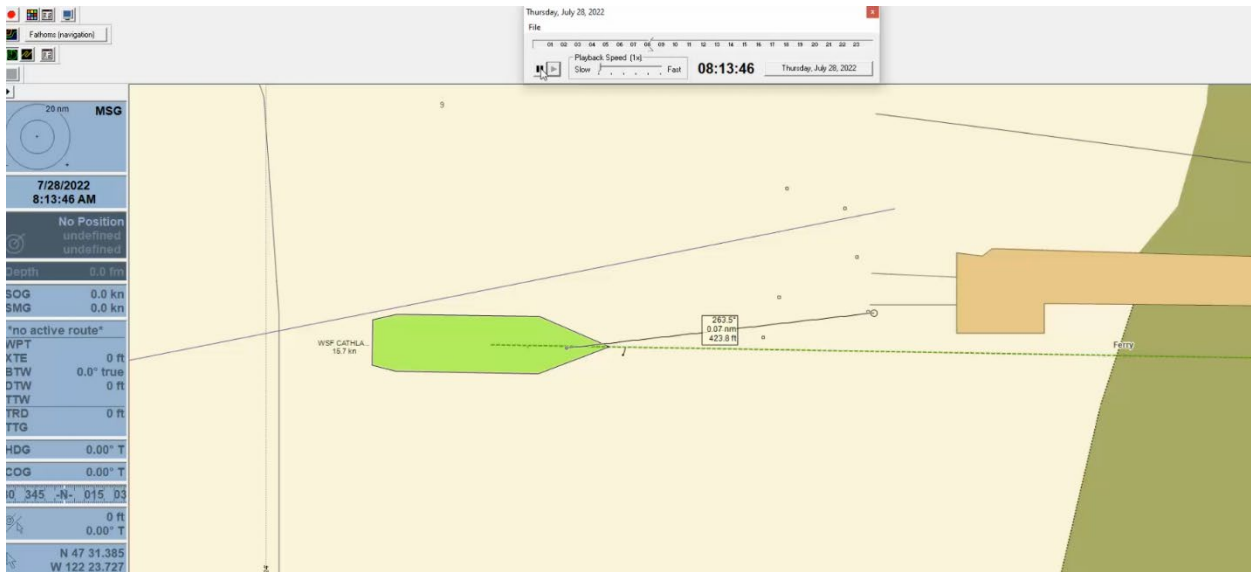
08:13:46 PDT stern rudder moved from center to right 35 deg.

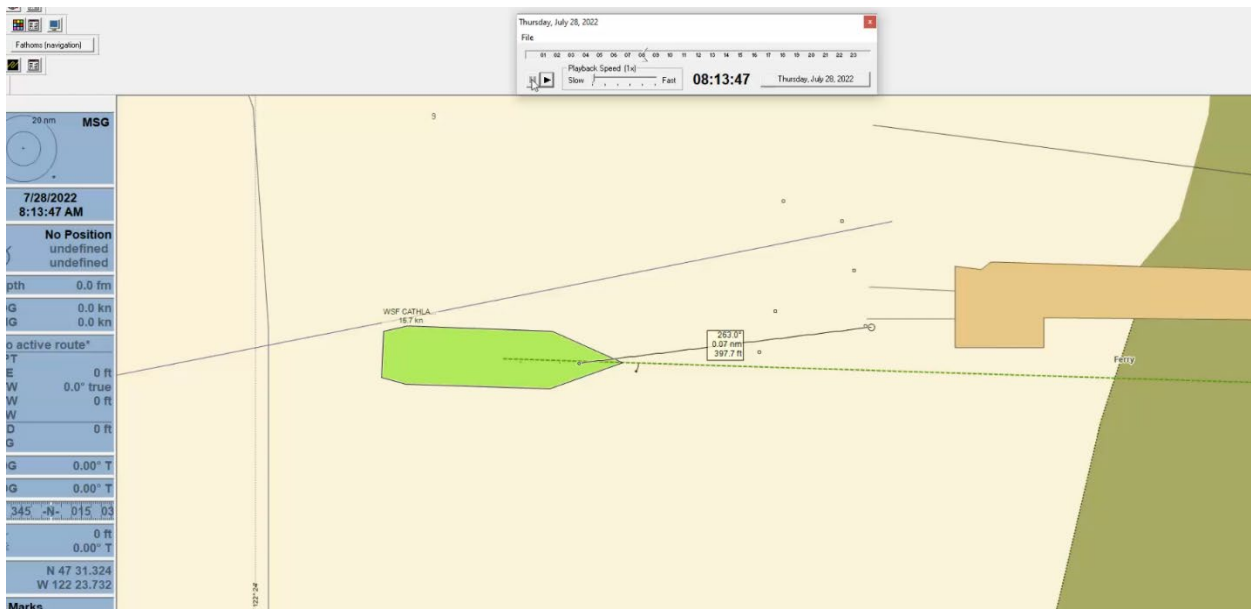
08:13:47 PDT bow handle moved from full feather position (position 10 ahead) to astern.

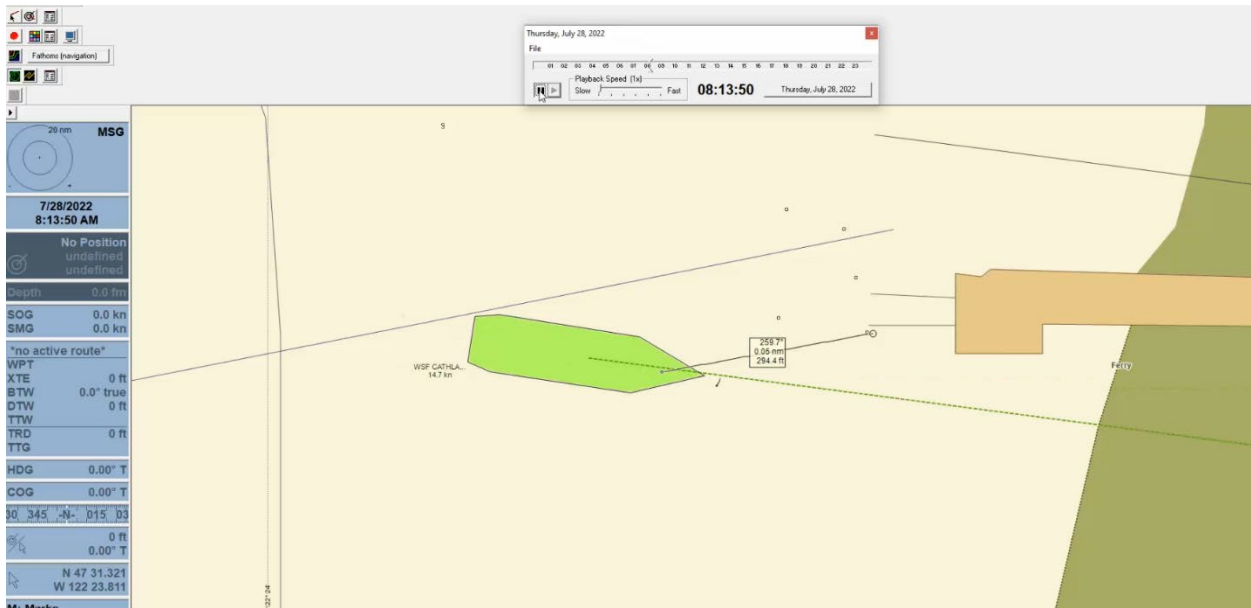
08:13:50 PDT bow rudder angle flops to 35 deg. right. Controller valves turn on to correct rudder.

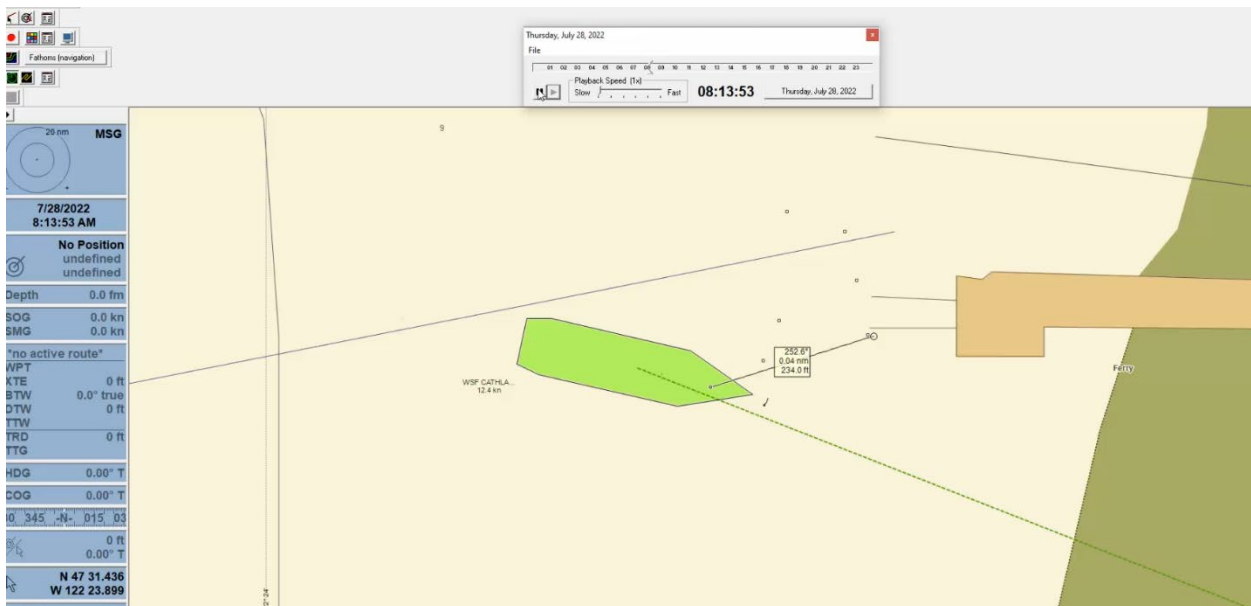
08:13:53 PDT bow handle moved from 8 to 10 astern.

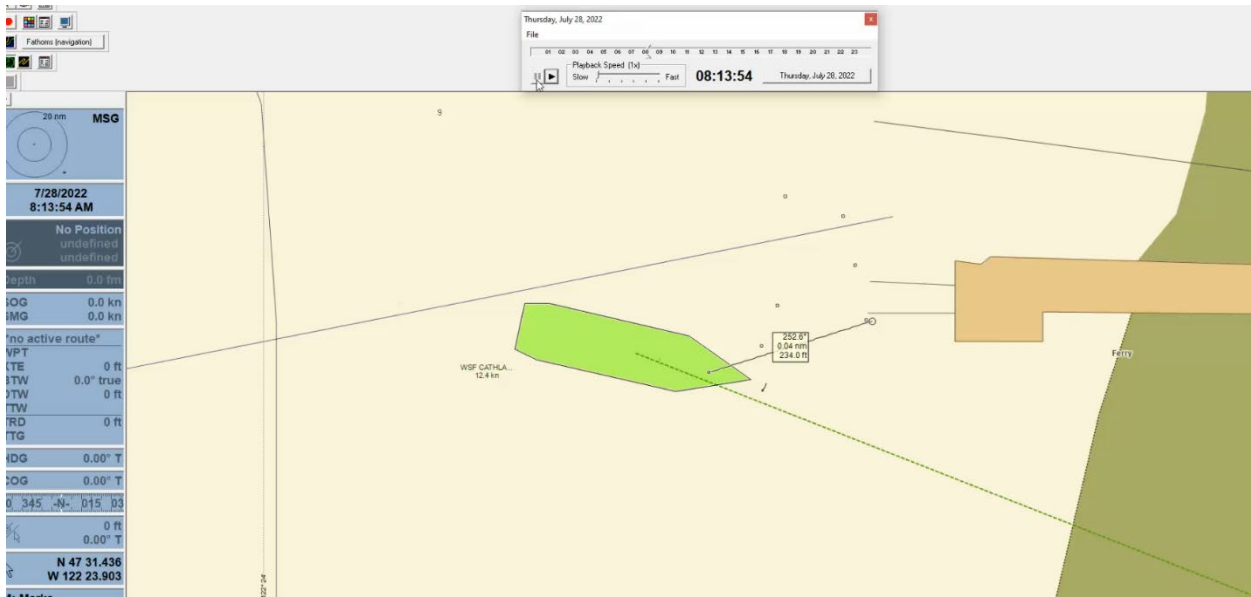
08:13:54 PDT stern handle moved from position 8 ahead to position 10 astern.

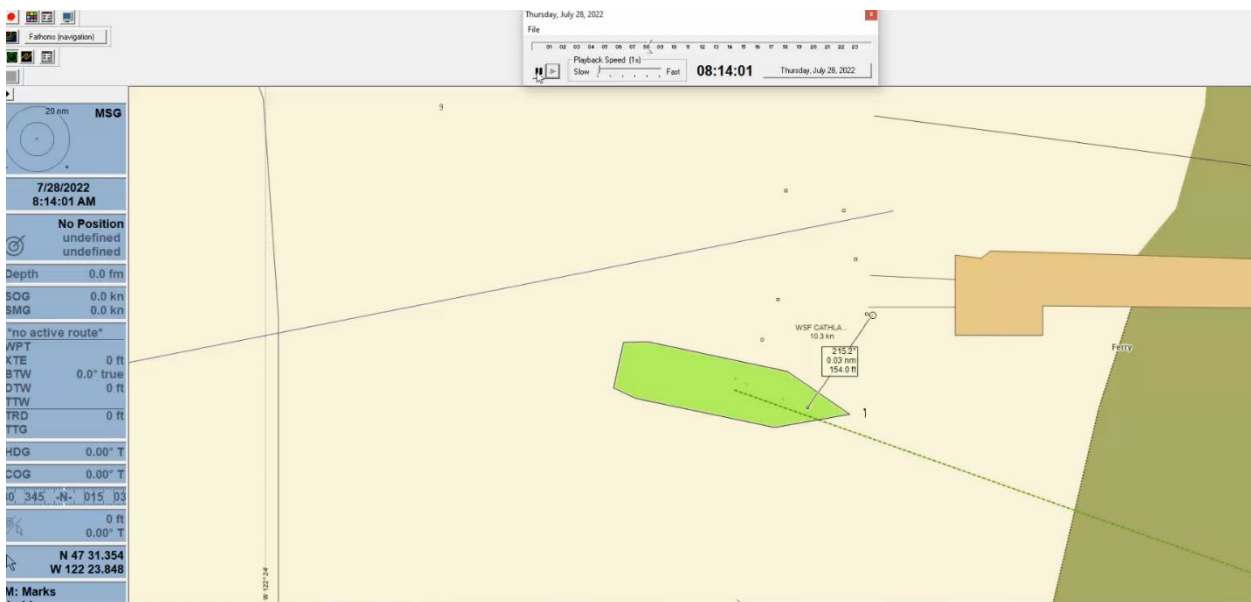
08:14:01 PDT bow propeller clutch engages.

5. Bow engagement. This is not logged in either of the logs, but the Chief and Assistant Engineer confirm that bow engagement was asked for.
6. Bow engagement occurred after the allision, at the approximate time the MV Cathlamet went aground.

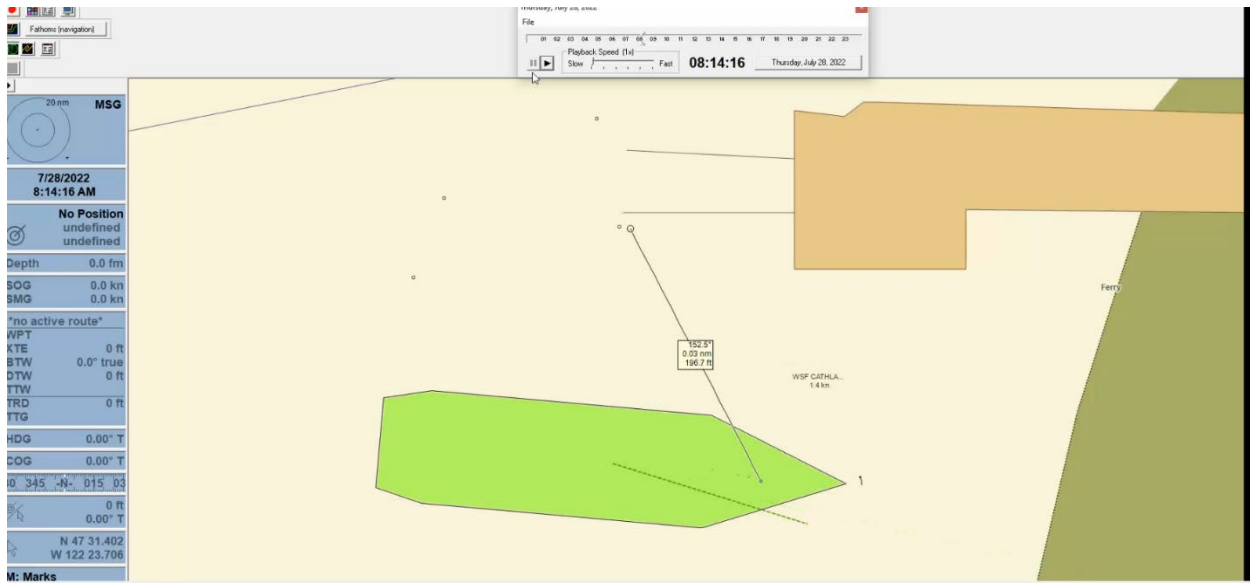
08:14:16 PDT bow handle reduces from 10 astern to zero.

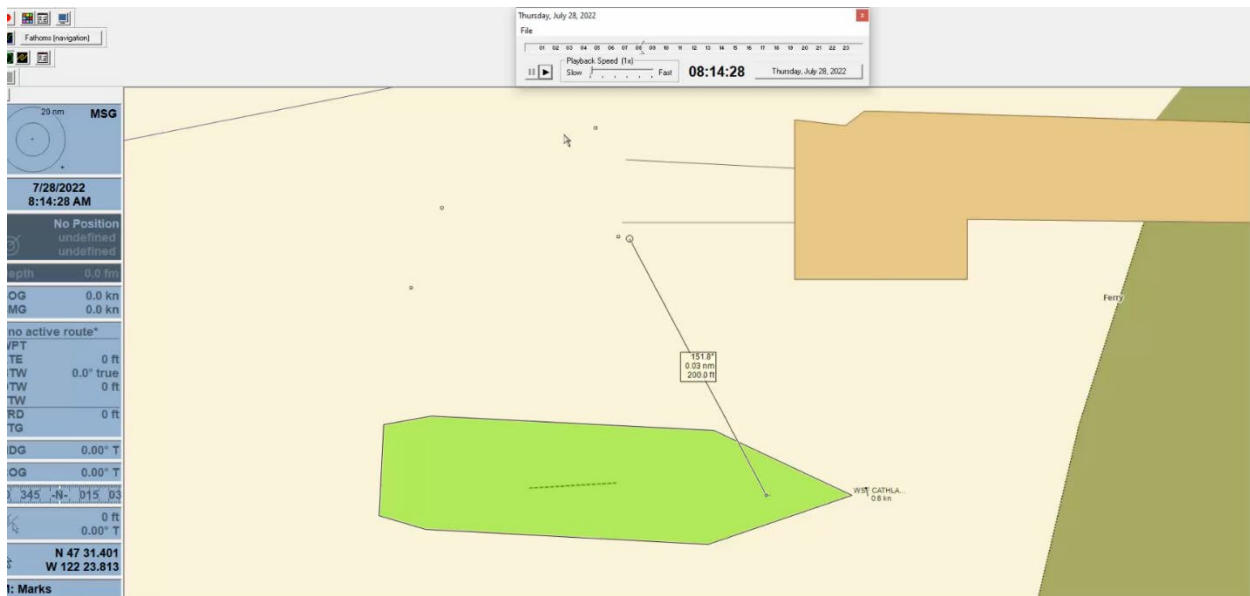
08:14:28 PDT bow handle moves from zero to 3.4 astern.

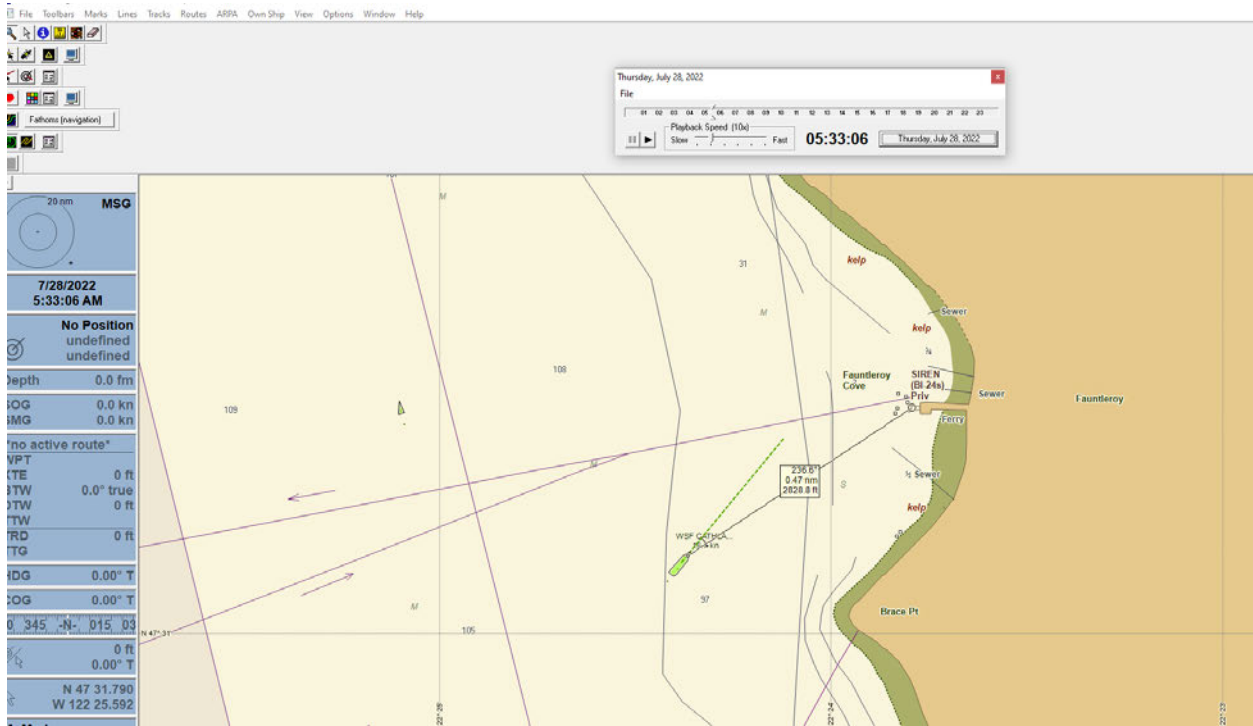
This shows the Cathlamet 0.5 NM off the Fauntleroy Terminal on an earlier trip from July 28, 2022. Since we don't have any other data, this is approximately when Captain [REDACTED] would have or should have assumed direct control over the maneuvering of the vessel in preparation for the landing.

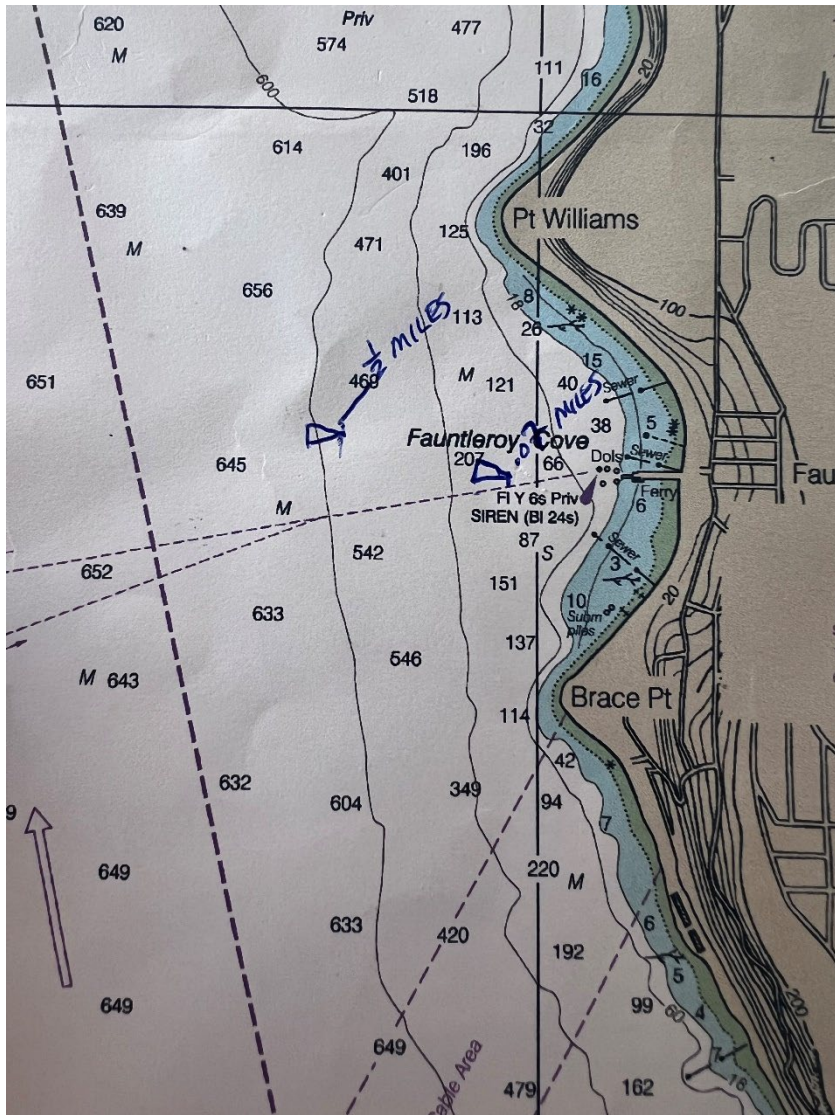
This is a depiction of the distance of where 0.5 NM is and where 0.07 NM is.

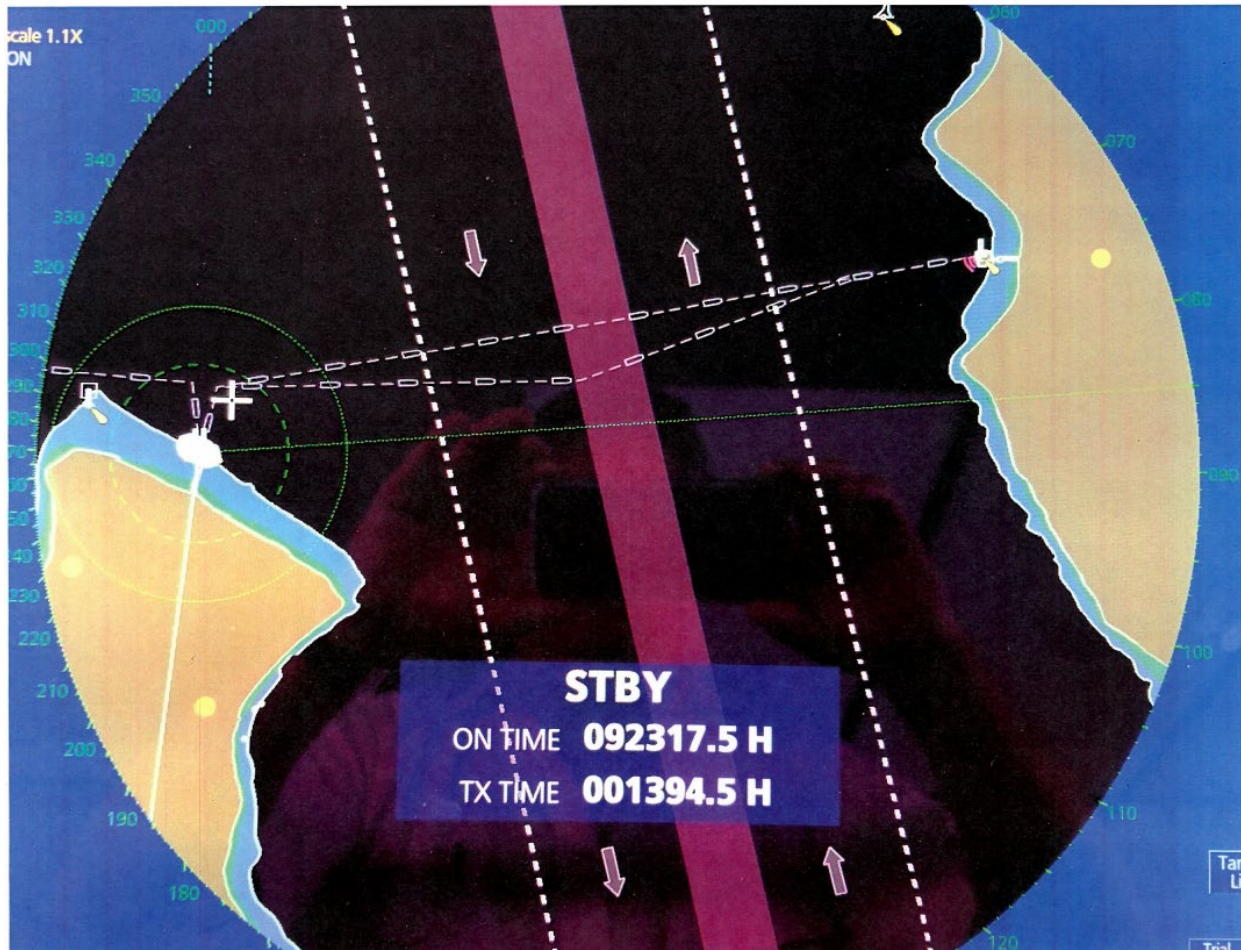
This picture – radar shot – shows two typical landing postures that Deck Officers take when landing at Fautleroy. One is obviously a ‘straight shot’ into the terminal and the other is a south approach. Based on the interview with the Quartermaster, Captain [REDACTED] preferred the south approach. Port Captain [REDACTED] confirmed this was his observation of Captain [REDACTED].

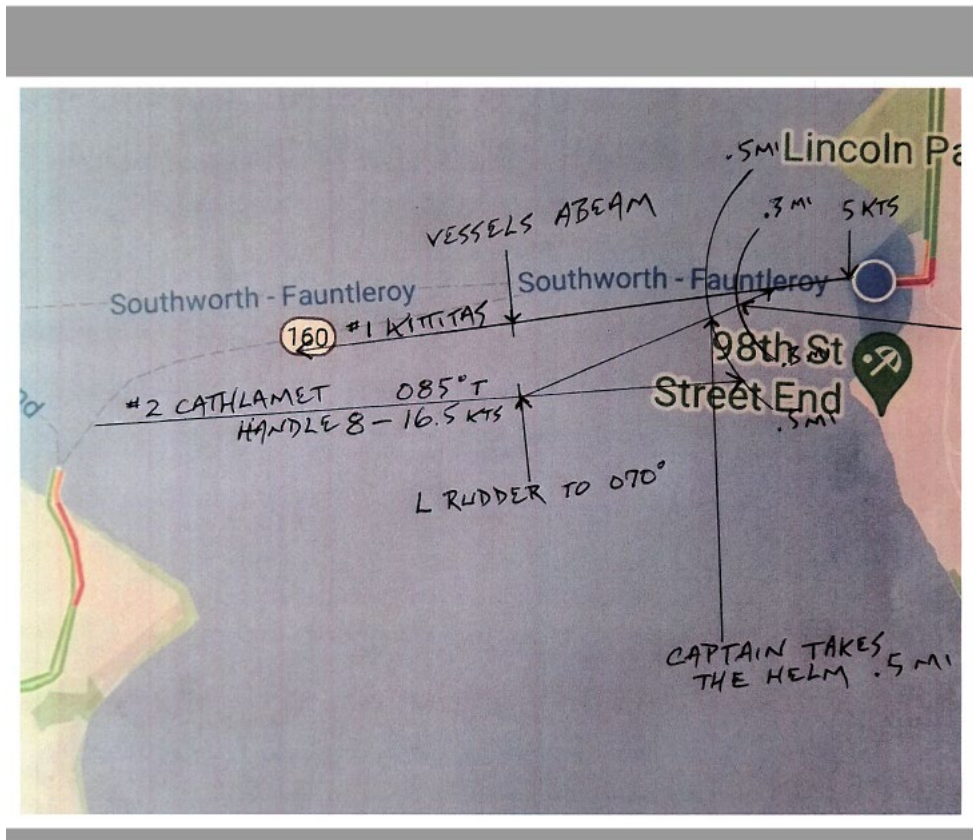
This picture depicts where the Deck Officer would take control of the vessel. This is per Safety Management System (SMS) procedures.
