Fish Passage and Stream Restoration Training

Biological Considerations

Damon Romero
WSDOT Fish Passage Coordinator

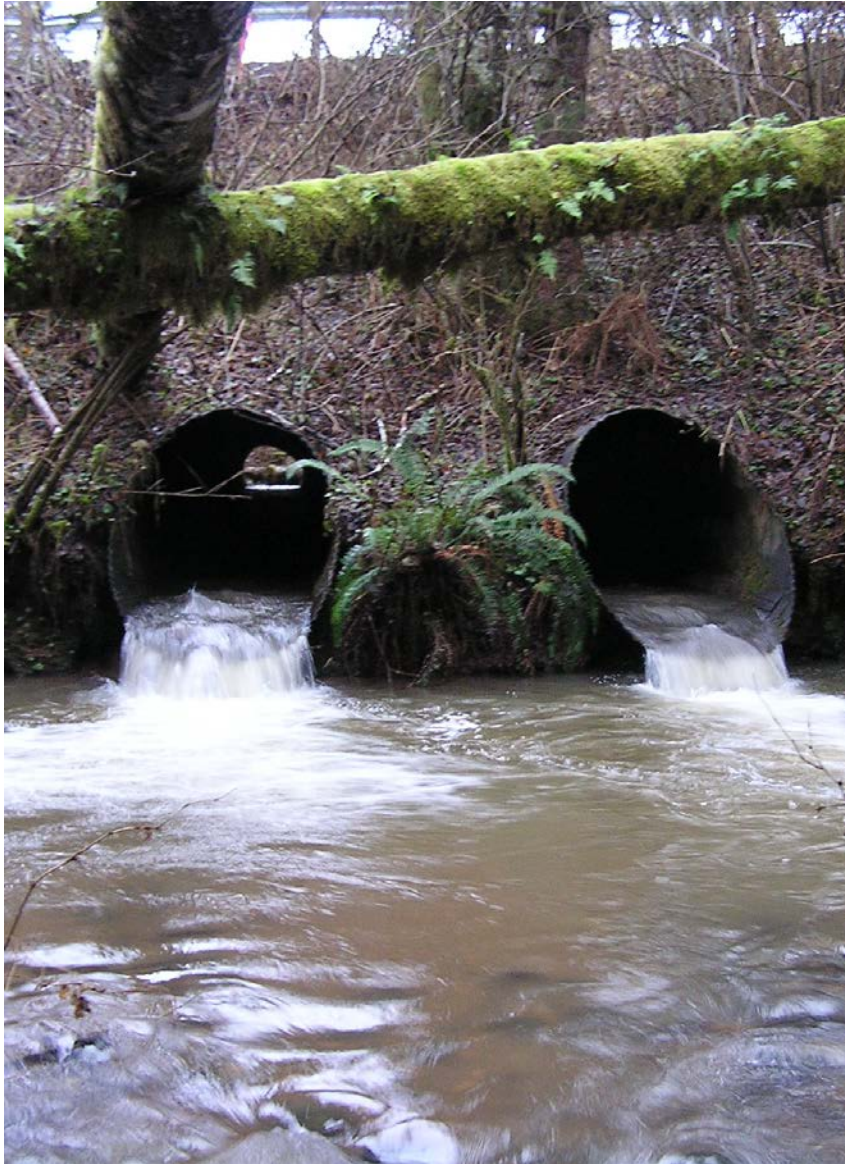
Level A Barrier Example: SR 112 Joe Cr.

- Almost all fish passage barriers are undersized
- Site 990214, pre-correction, was considered 67% passable (partial barrier) due to “WS Drop” or hydraulic drop of 0.85 feet
- If an adult fish made the jump into the culvert they would face 116 feet of very difficult conditions
- Outfall developed over time due to being undersized and creating excessive velocity

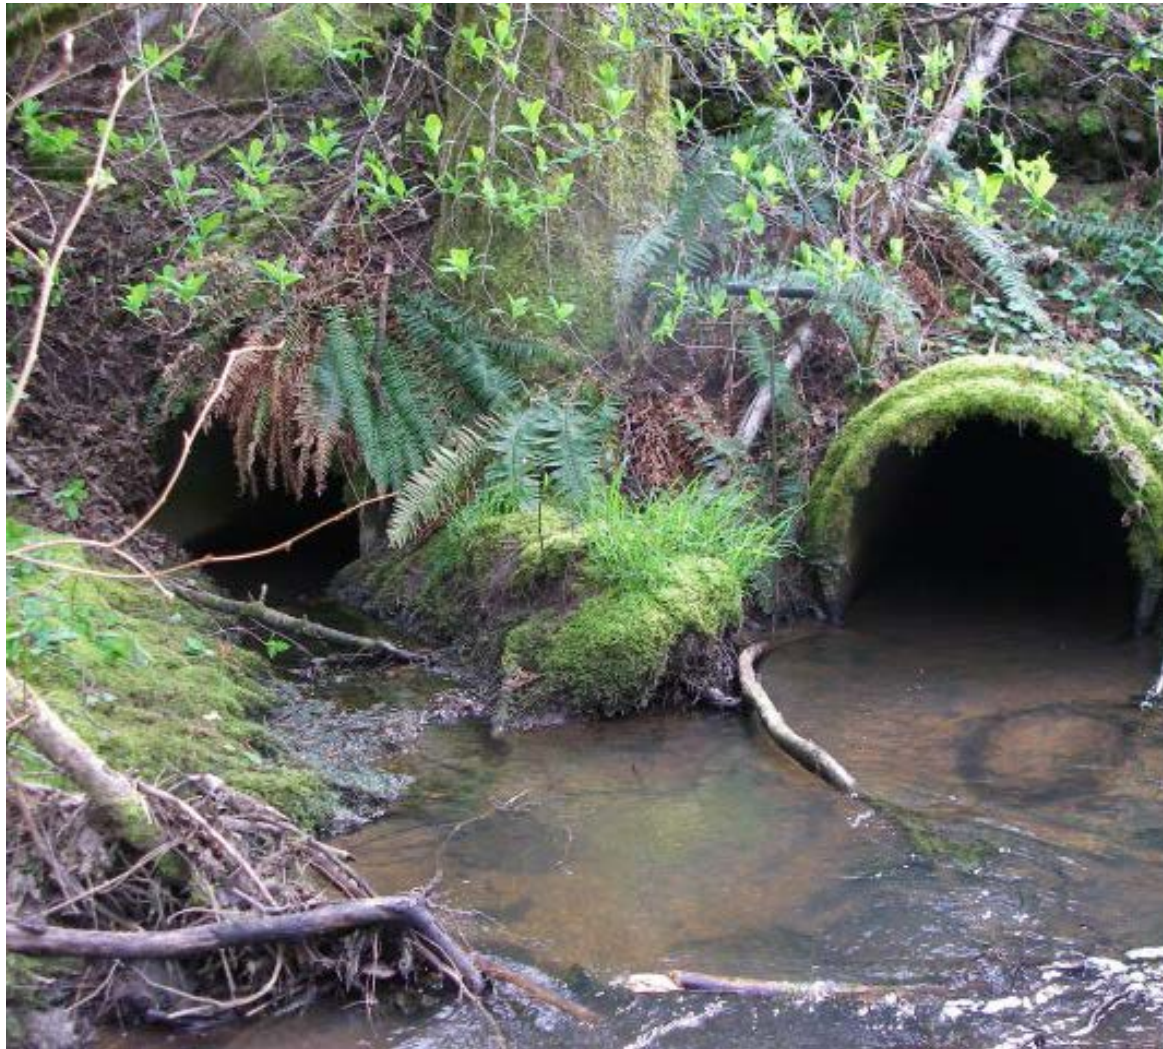
Level B Barrier Velocity Example: SR 112 UNT to Whiskey Creek

- Site 991693, located 17 miles east of Joe Creek.
- Twin 3' Concrete Pipes <math><0.4\%</math> slope
- Basin Area= 1.25 sq mi
- Precipitation= 75 inches
- Velocity>5 feet/second
- 67% passable

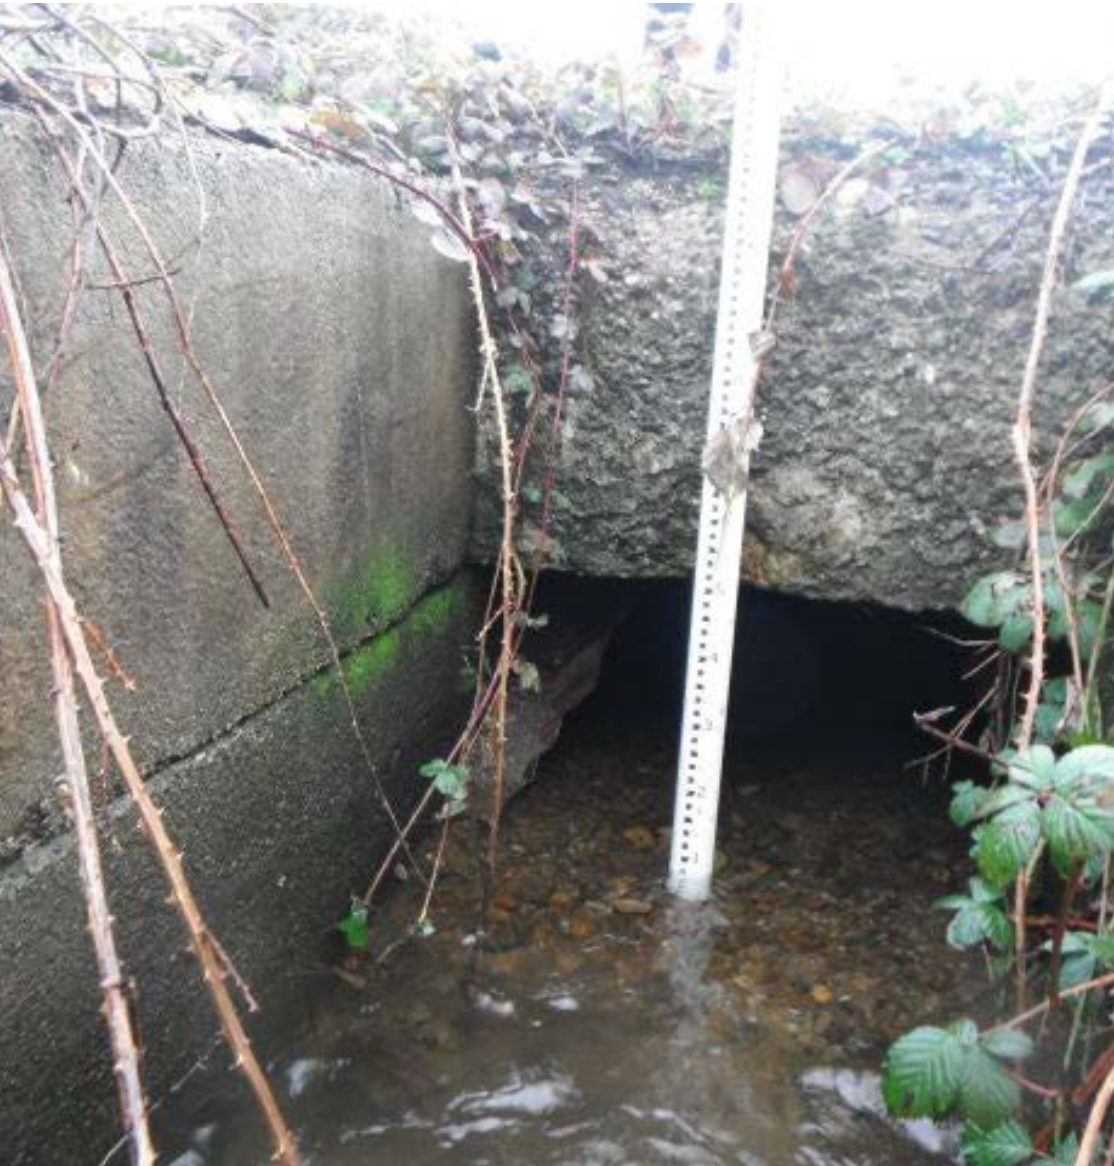
Level B Depth Barrier Example: SR 531 UNT to Edgecomb Creek

- Tiny Basin Area, 0.14 sq. mi.
- Annual Precipitation= 39.2"
- Level B results:
 - Velocity= 2.2 feet/second
 - Depth<2 inches at low-flow period
- 33% Passable

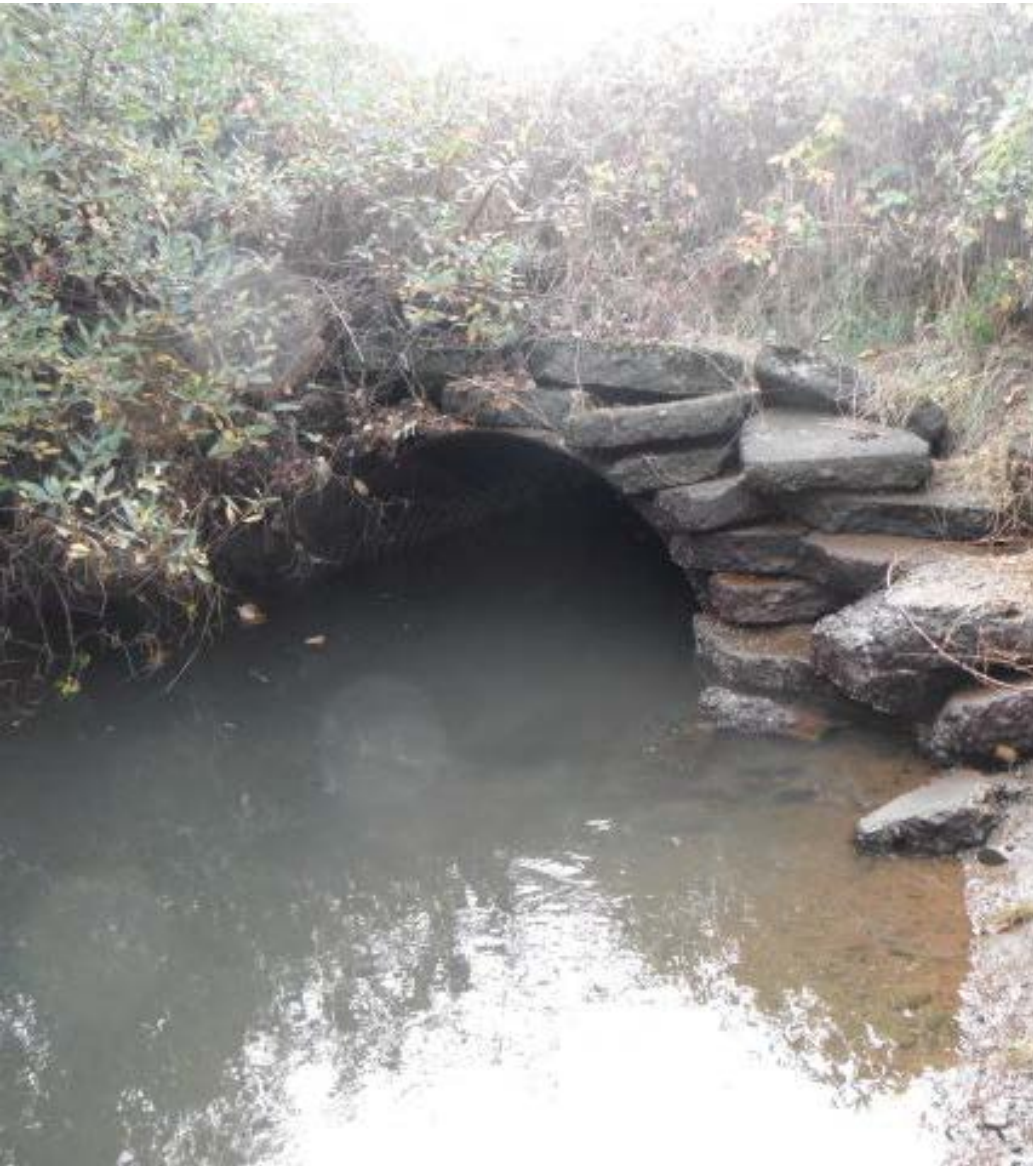
Tidal Velocity Barrier Example: SR 509 Wapato Creek

- Unknown barrier by Level A
- Level B not applicable due to tidal influence
- Requires WDFW Engineer Review

- Inadequate Depth observed
- Allowable velocity= 3 feet/second
- Tidal hydrology only= passable
- Tidal + Q_{fp} = 5.4 feet/second
- Predicted to be worse if downstream crossing were not limiting and attenuating tidal processes

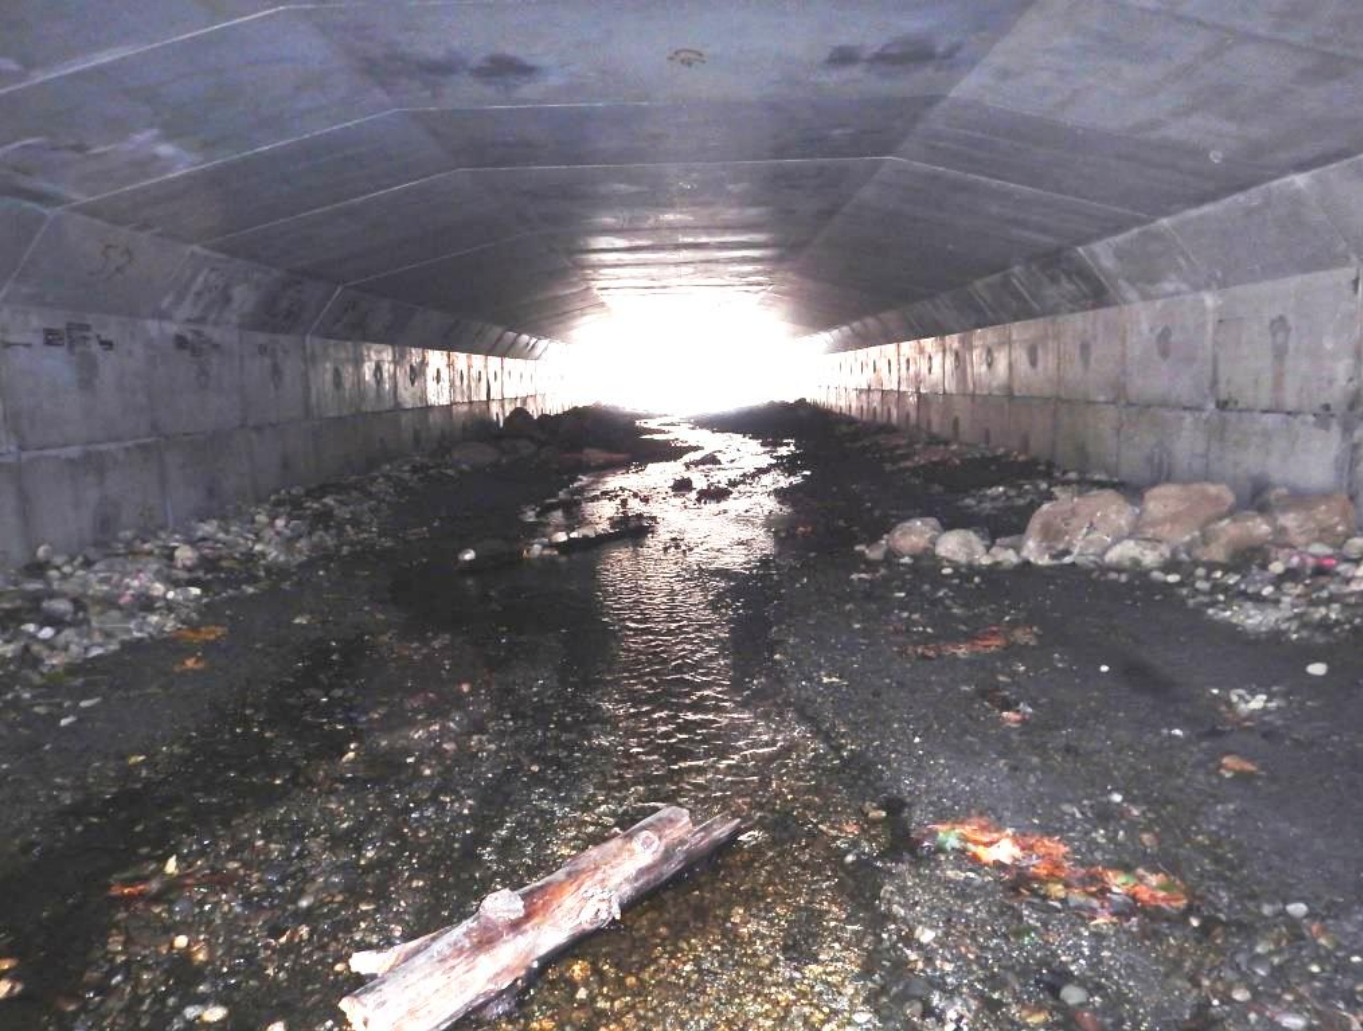
Entrainment= Velocity

- Depth insufficient for adult salmon-
- Pre-spawn mortality of female Pink salmon
- Will not trigger a Level B barrier status due to presence of bed material and adequate span

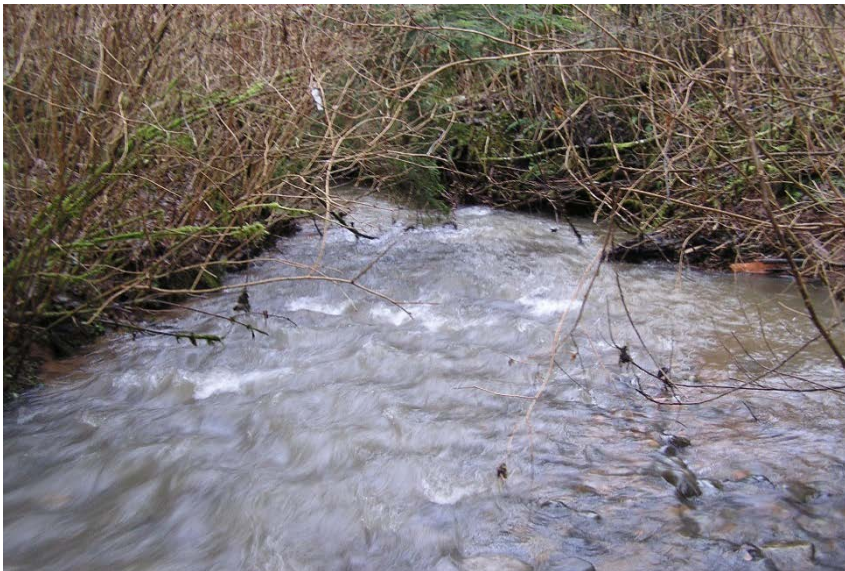
SR 112 MP 33.21 Joe Creek - 990214

Upper photo is upstream of SR 112

- Natural recruitment of LWM
- Habitat is complex with pools and riffles
- Well graded substrate

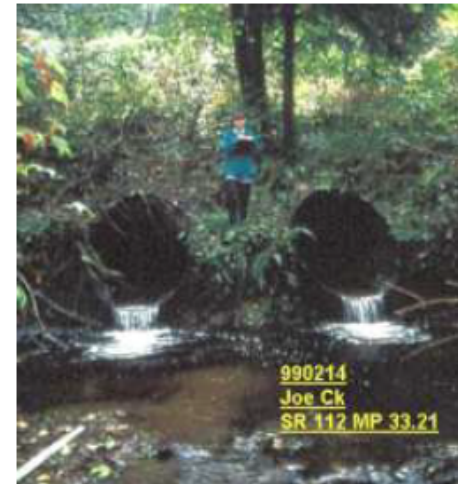
Culvert Details							Level A Parameters					
ID	Shape	Material	Span	Rise	Length	WDIC	Apron	WSDrop	Location	Countersunk	Backwater	Slope (%)
1.2	RND	SPS	1.52	1.52	35.40	0.12	NO	0.26		No		1.00
2.2	RND	SPS	1.52	1.52	35.40	-99.99	NO	0.26		No		1.00

Channel Description	
Toe Width (m):	3.2
Average Width (m):	-99.99
Culvert/Stream Width Ratio:	0.95
Plunge Pool	
Length (m):	5.50
Max Depth (m):	0.82
OHW Width (m):	9.45
Road	
Fill Depth (m):	3.00

Assessment Results			
Barrier:	<input type="text" value="Yes"/>	Passability (%):	<input type="text" value="67"/>
Reason:	<input type="text" value="WS Drop"/>	Fishway Present:	<input type="text" value="No"/>
		Method:	<input type="text" value="Level A"/>
		Recheck:	<input type="text"/>

Comments
1.2 = Log controls may work here (velocity isn't bad). May be steep downstream. Pipe is perched enough to block juveniles. On 10/20/04, RB culvert had a hole in the bottom near the upstream end. Probably more perforations throughout. 2.2 = Log controls (velocity isn't bad). May be steep downstream. Streambed is much wider than pipe upstream. Pipe is perched enough to block juveniles.
