## SR 520 BRIDGE REPLACEMENT AND HOV PROGRAM

## Decommissioning of old SR 520 floating bridge *Sixties-era structure now removed from Lake Washington*

# Decommissioning details

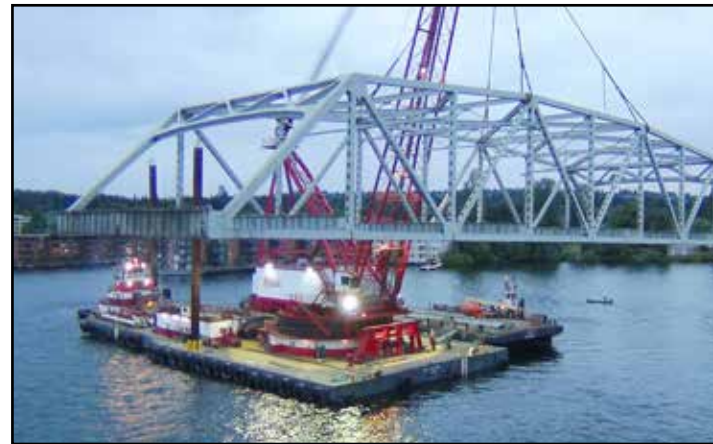
A derrick barge removes a metal truss from the old SR 520 floating bridge.

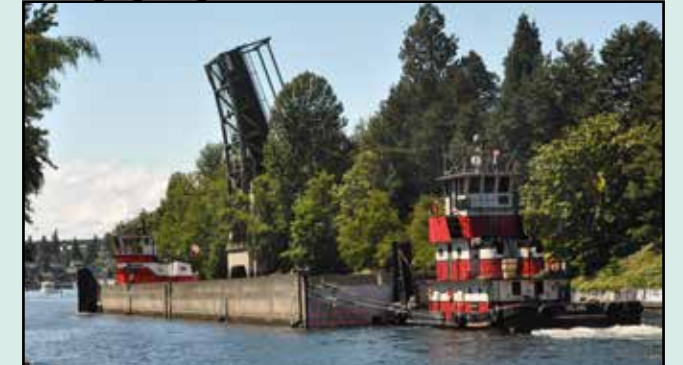
Tugboats escort a pontoon from the old SR 520 floating bridge off Lake Washington.

All 31 pontoons from the old floating bridge were separated, towed from the lake, and turned over to a third-party buyer. The pontoons may be repurposed as docks, piers, wharfs or other marine structures.
