SR 520 BRIDGE REPLACEMENT AND HOV PROGRAM

Decommissioning of old SR 520 floating bridge *Sixties-era structure now removed from Lake Washington*

Decommissioning details

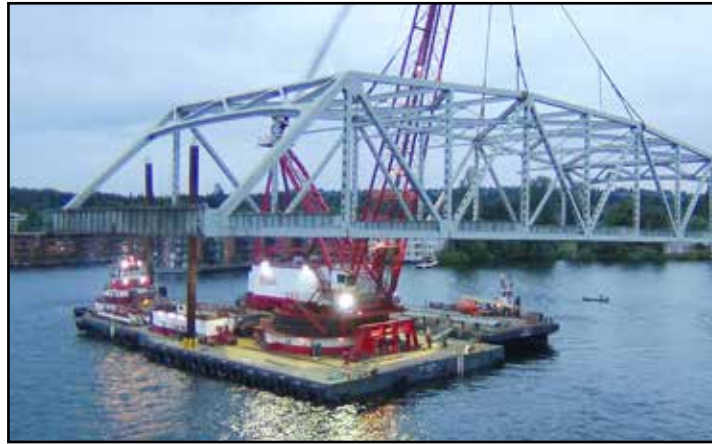
A derrick barge removes a metal truss from the old SR 520 floating bridge.

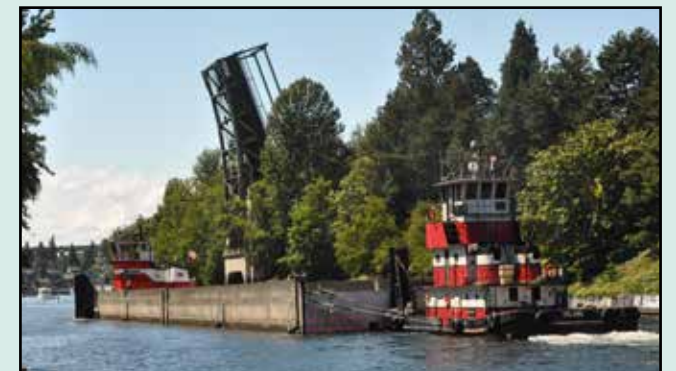
Tugboats escort a pontoon from the old SR 520 floating bridge off Lake Washington.

All of the pontoons were sold to NorthStar and left Lake Washington intact through the Hiram M. Chittenden locks in Ballard. The pontoons will be repurposed.

All 31 pontoons from the old floating bridge were separated, towed from the lake, and turned over to a third-party buyer. The pontoons may be repurposed as docks, piers, wharfs or other marine structures.
